Client/Project: Meadowlark Midstream Company, LLC  
 Blacktail Creek

Figure No. 5

Title: Control Measures - 2/7/2015

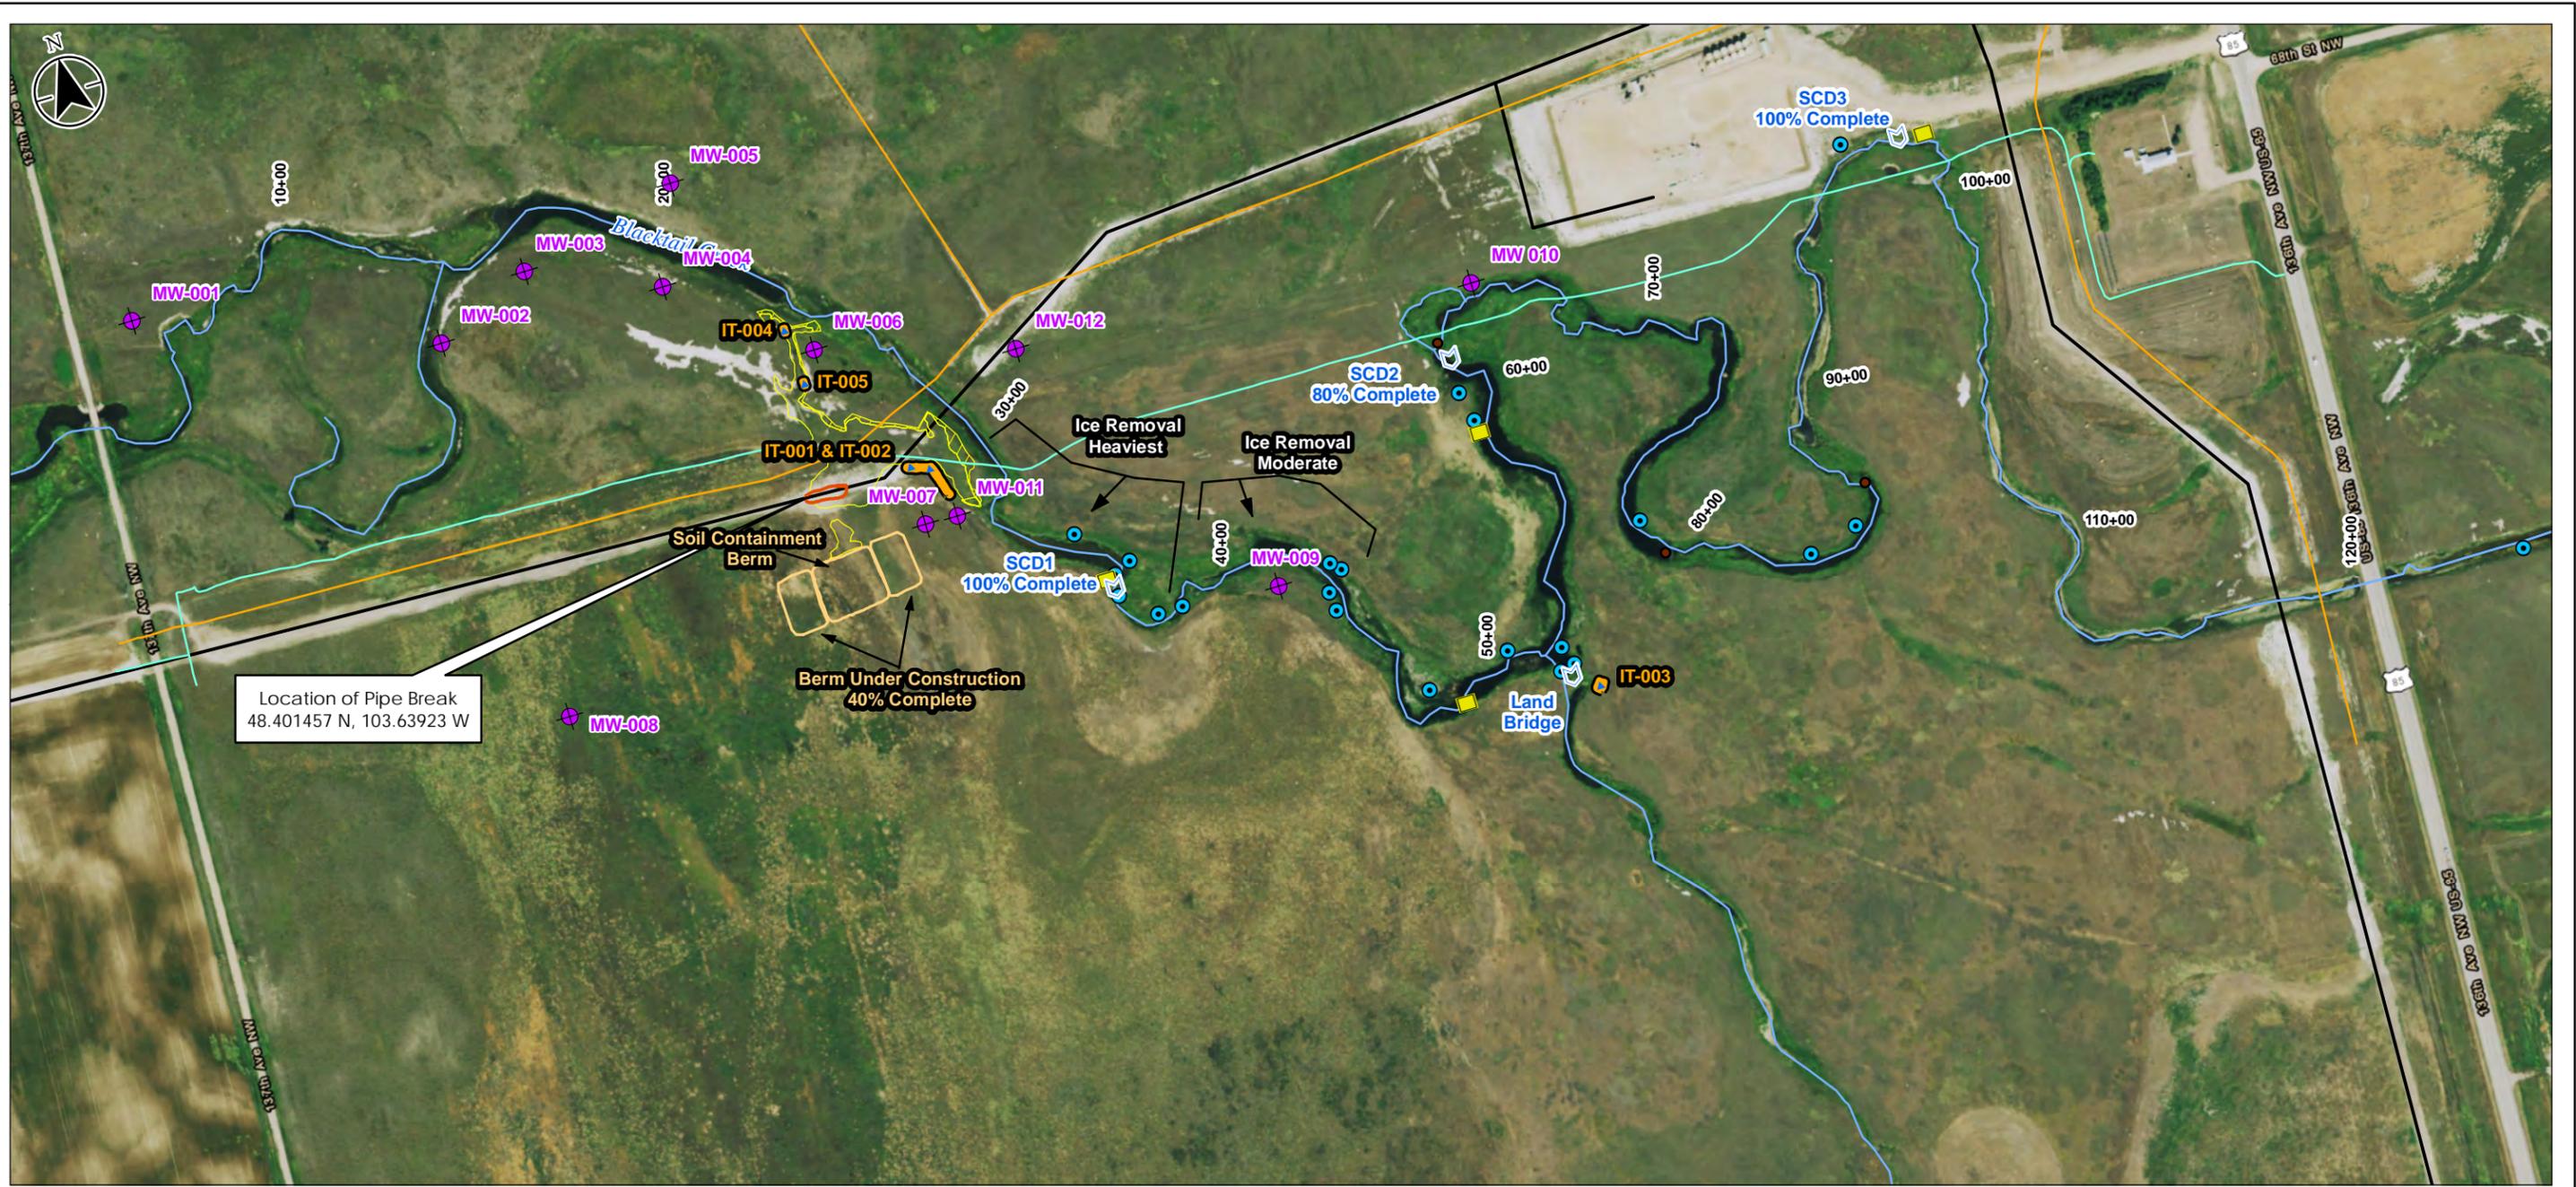
Location of Pipe Break  
48.401457 N, 103.63923 W
